## Pulpdent Embrace Restoration & PFM Repair Kit Review: Porcelain Repairs Made Easy

- By [Howard S. Glazer, DDS](#)

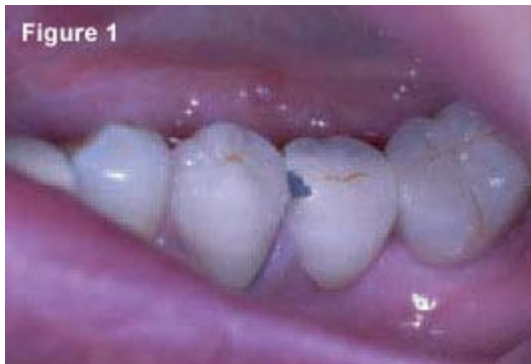
In the following case, the patient fractured the mesial-occlusal-buccal portion of the lower left first molar pontic (No. 19) on a 6-unit PFM fixed bridge (Figure 1). This was unusual because the patient has passive occlusion on this tooth and no other porcelain fractures were noted. The fracture was noticeable when the patient smiled. If allowed to remain, the cracked, exposed porcelain would continue to chip away. It needed to be repaired to maintain the integrity of the bridge and satisfy the patient's esthetic needs. It is important to create as much mechanical retention as possible to have the best chance for a successful repair.<sup>1</sup> Roughing up the metal surface with a fine diamond is imperative, and undercuts are valuable for retention form (Figure 2).

**Figure 1** — Shows fracture of the mesialocclusal- buccal portion of the lower left first molar pontic (tooth No. 19) on a 6-unit porcelain-fused-to-metal fixed bridge.

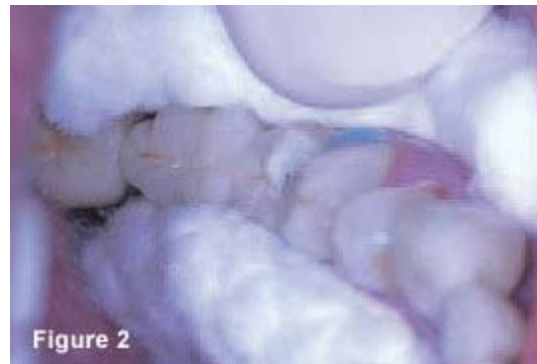
**Figure 2** — Kool-Dam was used to protect the gingiva and isolate the area to be repaired, ensuring a dry field and masking areas not to be etched.

Before etching the porcelain, make sure that the soft tissue is protected. Isolation with cotton rolls or a rubber dam is recommended. In this case, Kool-Dam light-cured liquid dam (supplied in the kit) was used to protect any exposed tissue (Figure 2). Kool-Dam stays cool, remains flexible when cured, and is easily removed in 1 piece.

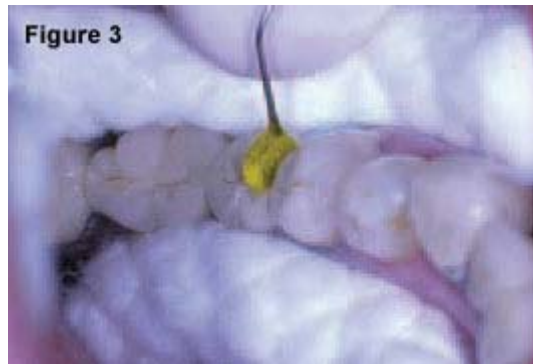
**Figure 3** — Pulpdent Porcelain Etch Gel (yellow) was then applied for 2 minutes.

A valuable tip when doing this procedure is to extend the etched porcelain surface beyond the fractured surface and onto the smooth porcelain. I do this routinely in these kinds of cases to increase the etched surface area for bonding and retention (Figure 3).

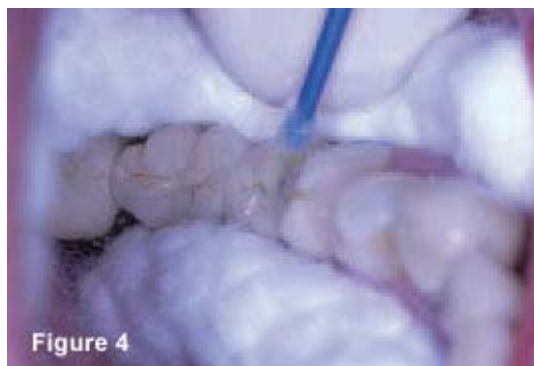
**Figure 4** — After etching, rinsing, and drying, Embrace First-Coat was applied to the etched and abraded surfaces with a brush applicator, thinned with a gentle stream of air, and light cured for 20 seconds.

Also included in this new system is Embrace First-Coat. According to the manufacturer's instructions, First-Coat is a light-cured resin primer that replaces silane and metal adhesives and is placed on both the porcelain and metal surfaces. Since the 1980s, dentists have used silane to act as a coupling agent to enhance the bond between inorganic porcelain and the organic resin used to repair the fractured crown. I have always suspected silane to be the weak link in traditional repair techniques, and my experience, as well as among others' suggests there is limited and inconsistent success with the old silane systems. In my opinion Embrace First-Coat represents the first significant improvement in porcelain repair in 2 decades, and it has provided a dramatic increase in success rates in my practice. In vitro shear bond strength testing by the manufacturer indicates that the bond between First-Coat and porcelain is stronger than the cohesive strength of porcelain itself at the resin–porcelain interface. Clearly this is the key factor.

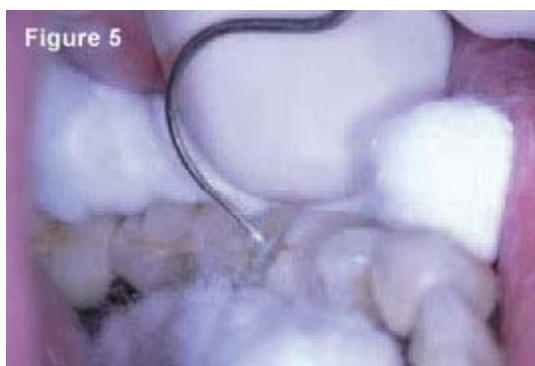
**Figure 5** — Embrace Opaquer was placed in the center of the exposed metal and carefully spread with an explorer so that it was not on the beveled porcelain margin. The opaquer was light-cured for 20 seconds.

After applying First-Coat (Figure 4), Embrace Opaquer, which cures in just 20 seconds, can be used to mask metal or discolored surfaces (Figure 5). [Heraeus Kulzer's Venus composite resin](#) was placed over the opaque layer and light-cured for 20 seconds (Figure 6). The restoration was then contoured and finished using SS White finishing burs and polished with [Clinician's Choice Groovy Diamond Polishing Brushes](#).

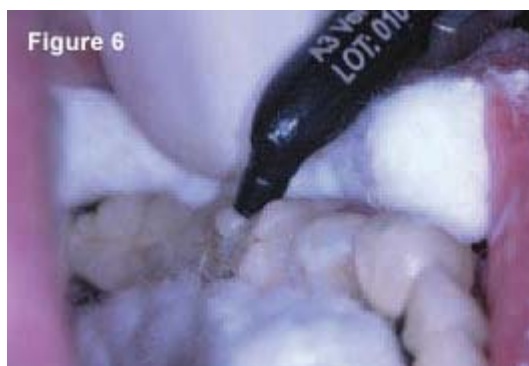
**Figure 6** — Venus composite resin (Heraeus Kulzer) was placed over the opaque layer and light-cured for 20 seconds.

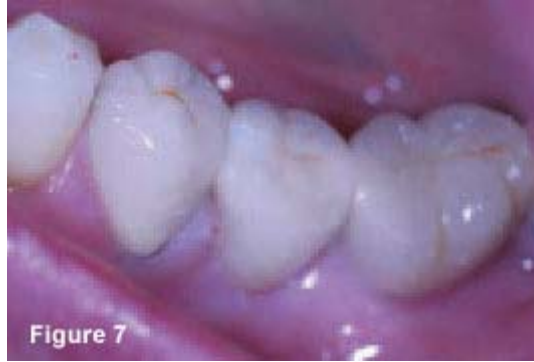
**Figure 7** — A final finish is achieved with Embrace Seal-n-Shine, which was light-cured for 20 seconds.

Next, Seal-n-Shine was used to seal the margins against micro leakage and provide the final finish and polish to the composite and porcelain surface (Figure 7).
